THERMO-MECHANICAL CHARACTERIZATION OF
SILICON CARBIDE-SILICON CARBIDE COMPOSITES
AT ELEVATED TEMPERATURES USING A UNIQUE
COMBUSTION FACILITY

DISSERTATION

AFIT/DS/ENY/09-S01

AIR FORCE INSTITUTE OF TECHNOLOGY

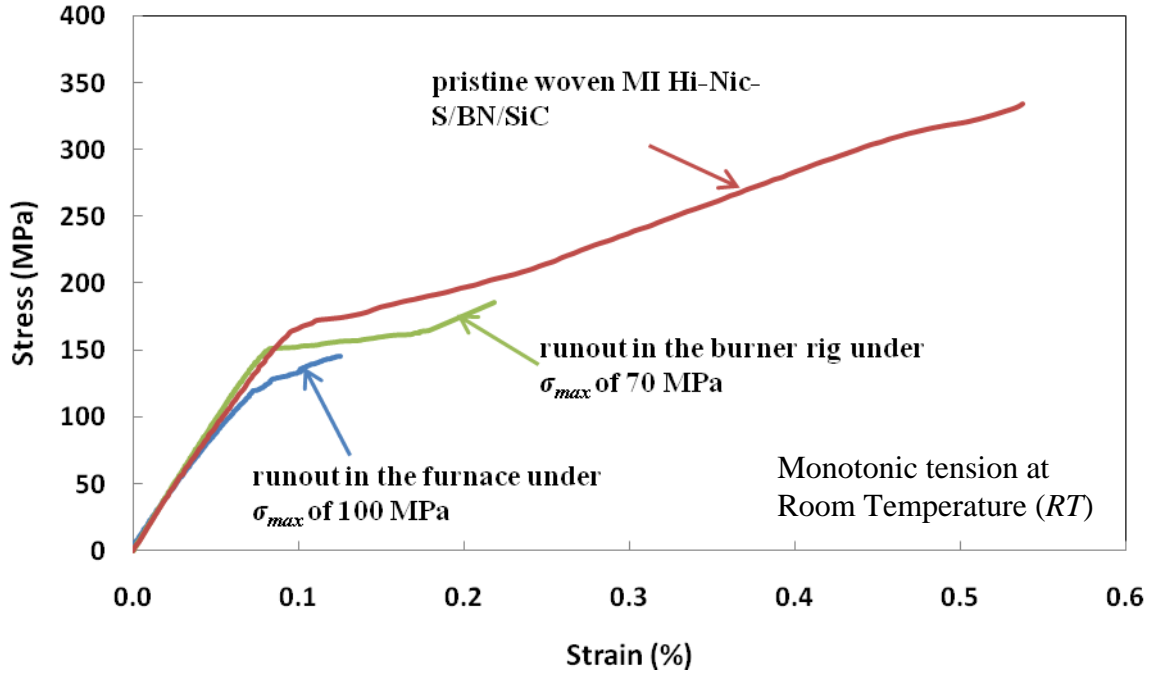
Figure 61: Stress-strain curves of the runout and pristine MI woven Hi-Nic-S tested under monotonic tension

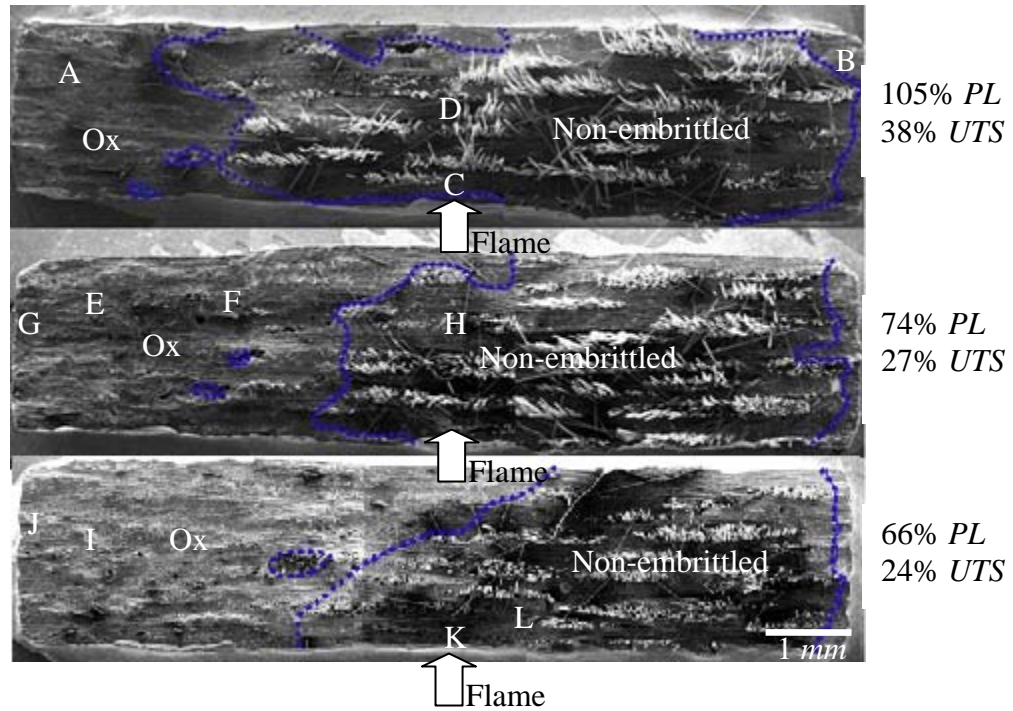
Figure 62: Fracture surface at peak stresses of 105%, 74% and 66% of *PL*

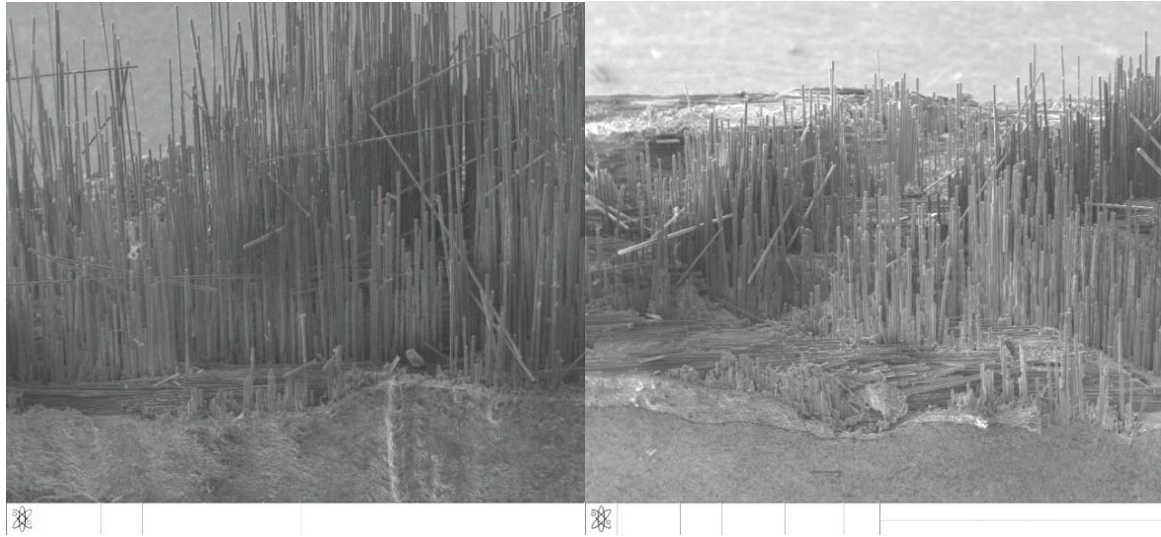
Figure 63: Fiber pullouts on fracture surfaces of the woven MI Hi-Nic-S/BN/SiC failed under the peak stress of 105% (Left) and 66% of the RT *PL* (Right)

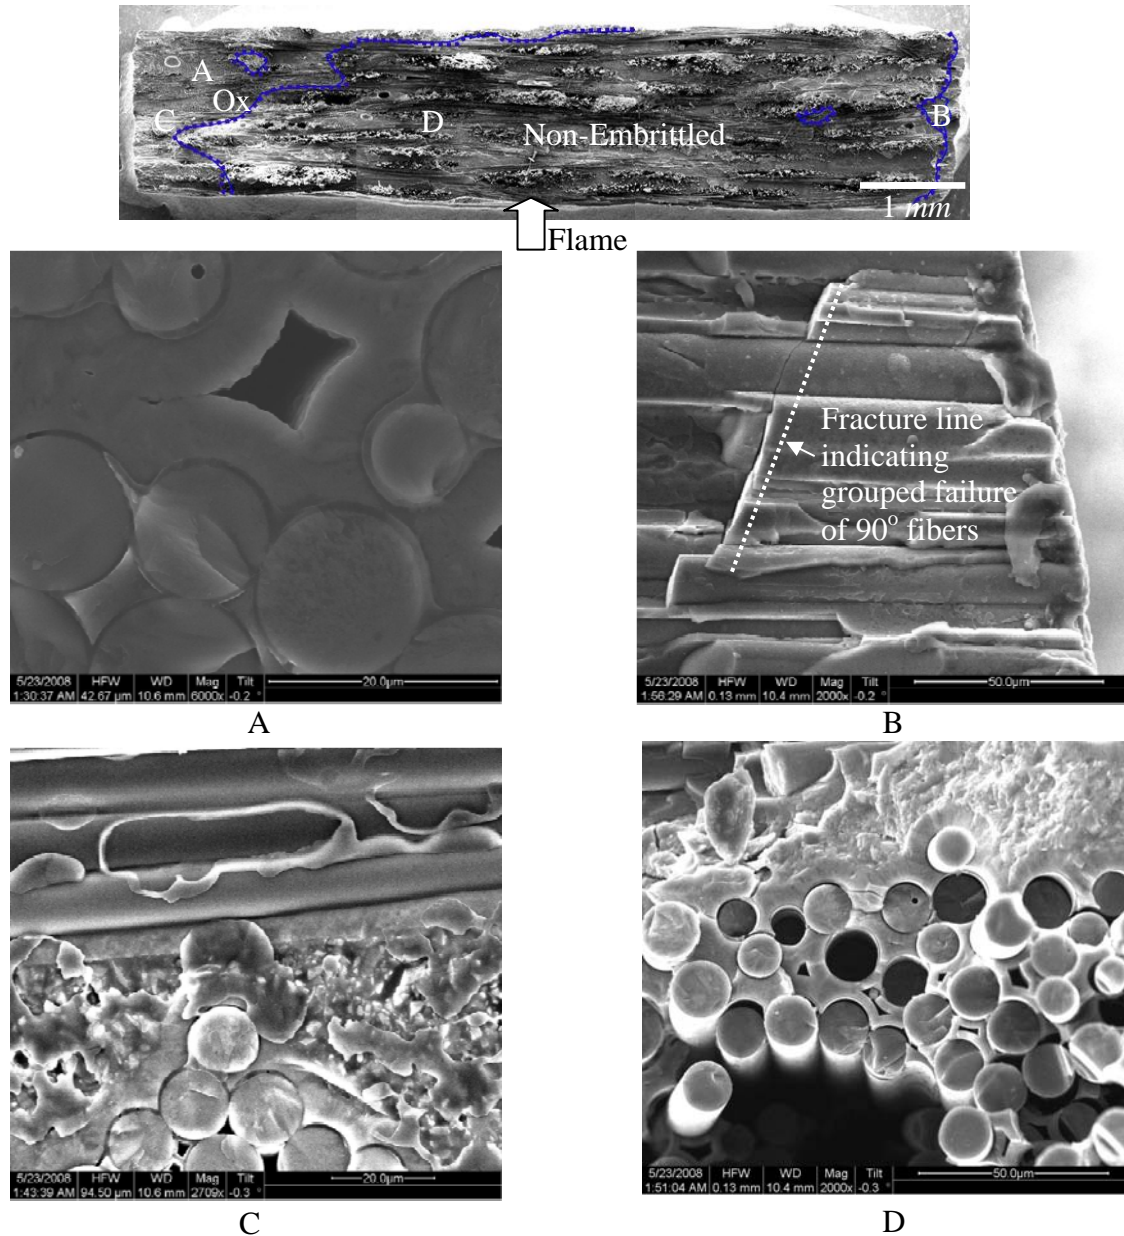
Figure 67: Fracture surface of the runout MI woven Hi-Nic-S/BN/SiC after residual strength test: A thru D are from the oxidized and non-embrittled regions of the residual fracture surface as denoted on the above image.

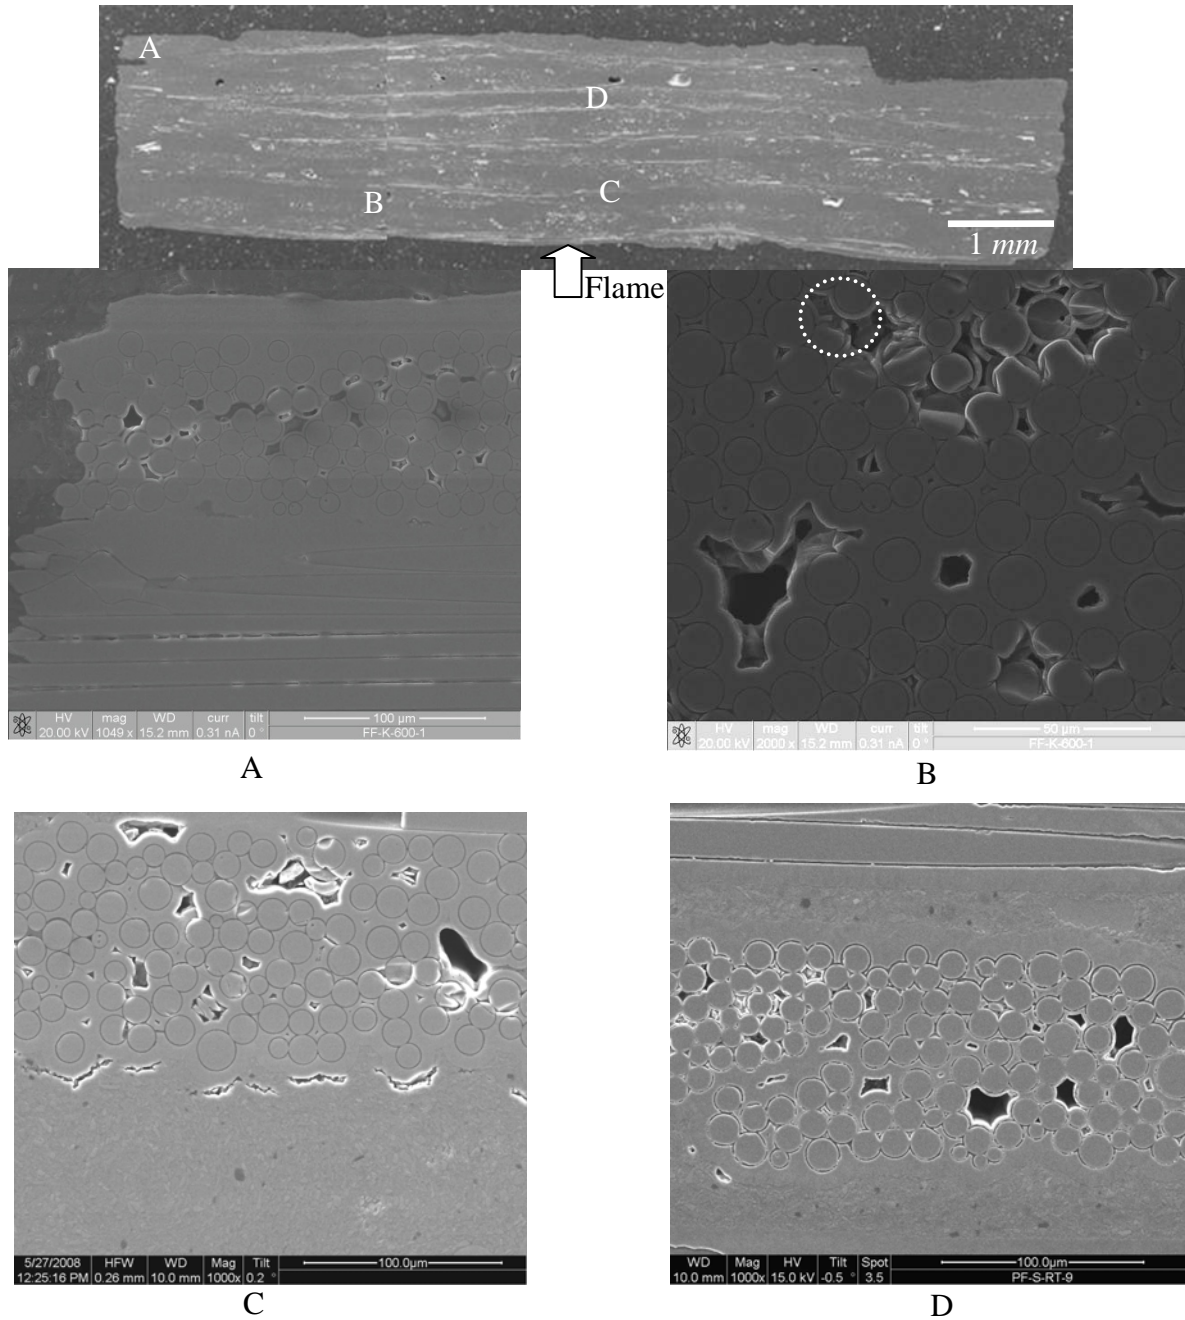
Figure 68: Polished section from heated zone of runout woven MI Hi-Nic-S/BN/SiC: A thru D are from the sectioned surface as denoted on the above.

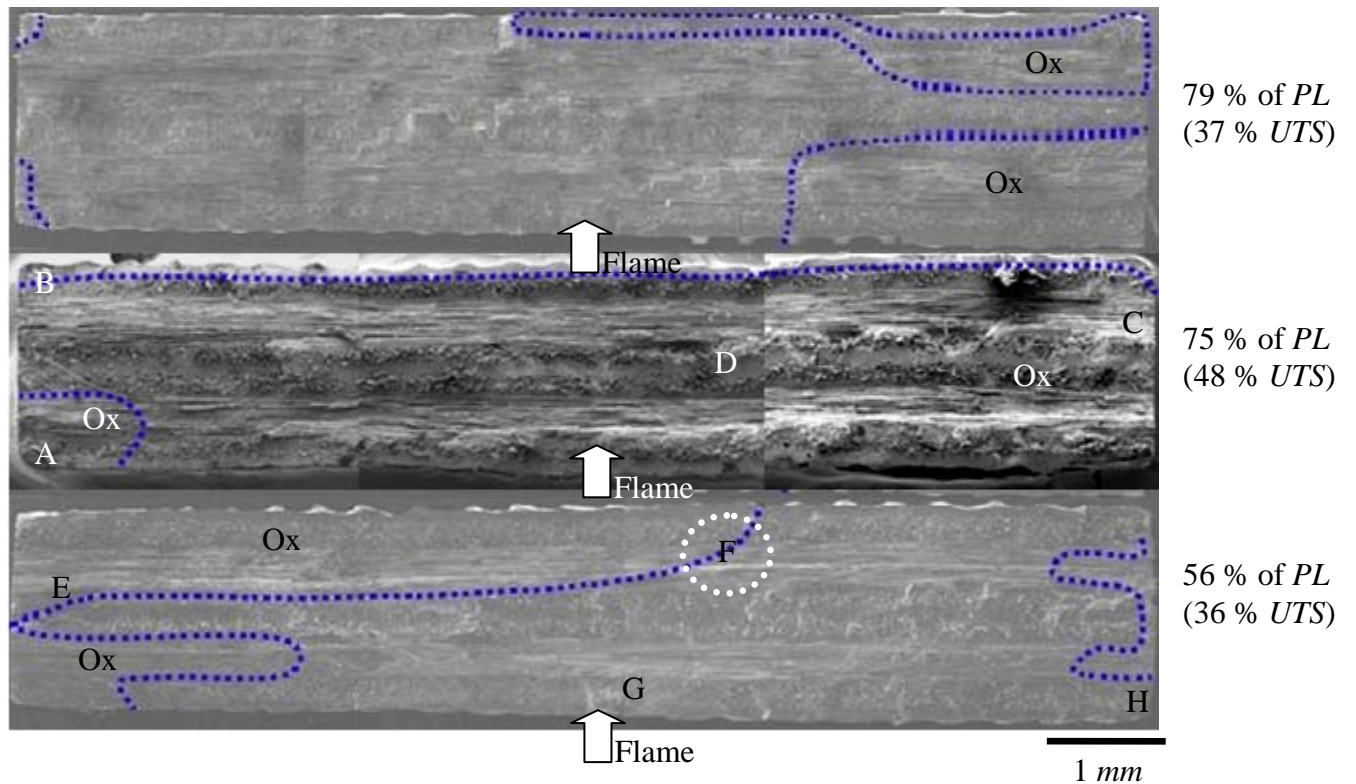
Figure 72: Fracture surfaces of the prepreg MI Hi-Nic-S/BN/SiC CMCs fatigued at 79%, 75% and 52% of *PL*

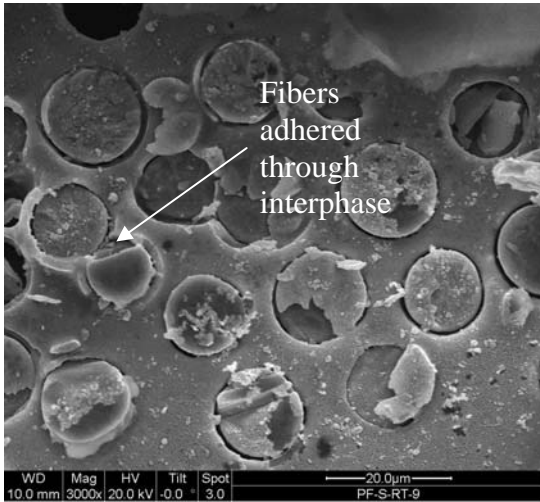
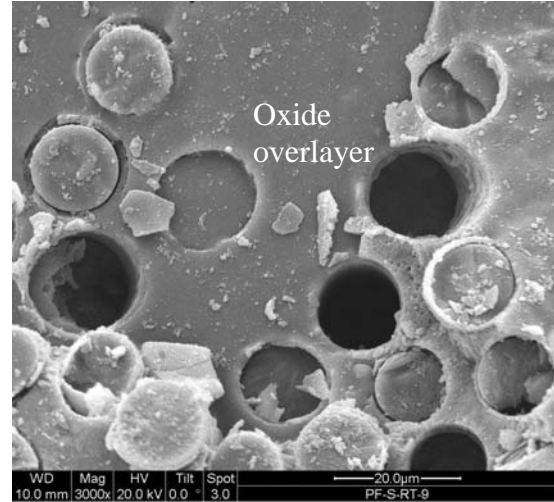
Figure 73: Microstructure of the MI prepreg Hi-Nic-S/BN/SiC fatigued at peak stress of 75% of *PL*: A thru D are from the fracture surface as shown on Figure 72.

The microstructures commonly observed throughout the oxidized and non-embrittled regions of the two specimens fatigued at 75% and 56% of their respective *PL* are presented in Figure 73 and Figure 74, respectively. Fibers adhered to their neighbors through the contacting interphases that became rigid by oxidation were observed as shown in Figure 73A, though not as common as in the woven MI CMCs. Oxide overlayers formed on the fracture surface were observed throughout the oxidized regions on the fracture surfaces characterized as single-and multi-planar crack planes, as shown in Figure 73A and B & Figure 74. Unlike the woven MI CMCs, the prepreg MI CMC with much shorter combustion exposure did not exhibit much edge oxidation. In the non-embrittled region, fiber pullouts showing no interphase oxidation were observed as shown in Figure 73C and D & Figure 74H. As compared to the woven MI CMCs, the prepreg MI Hi-Nic-S/BN/SiC showed much shorter pullouts, suggesting different modes of governing the fiber-interphase and matrix-interphase interactions under fatigue than those in the woven MI CMCs.

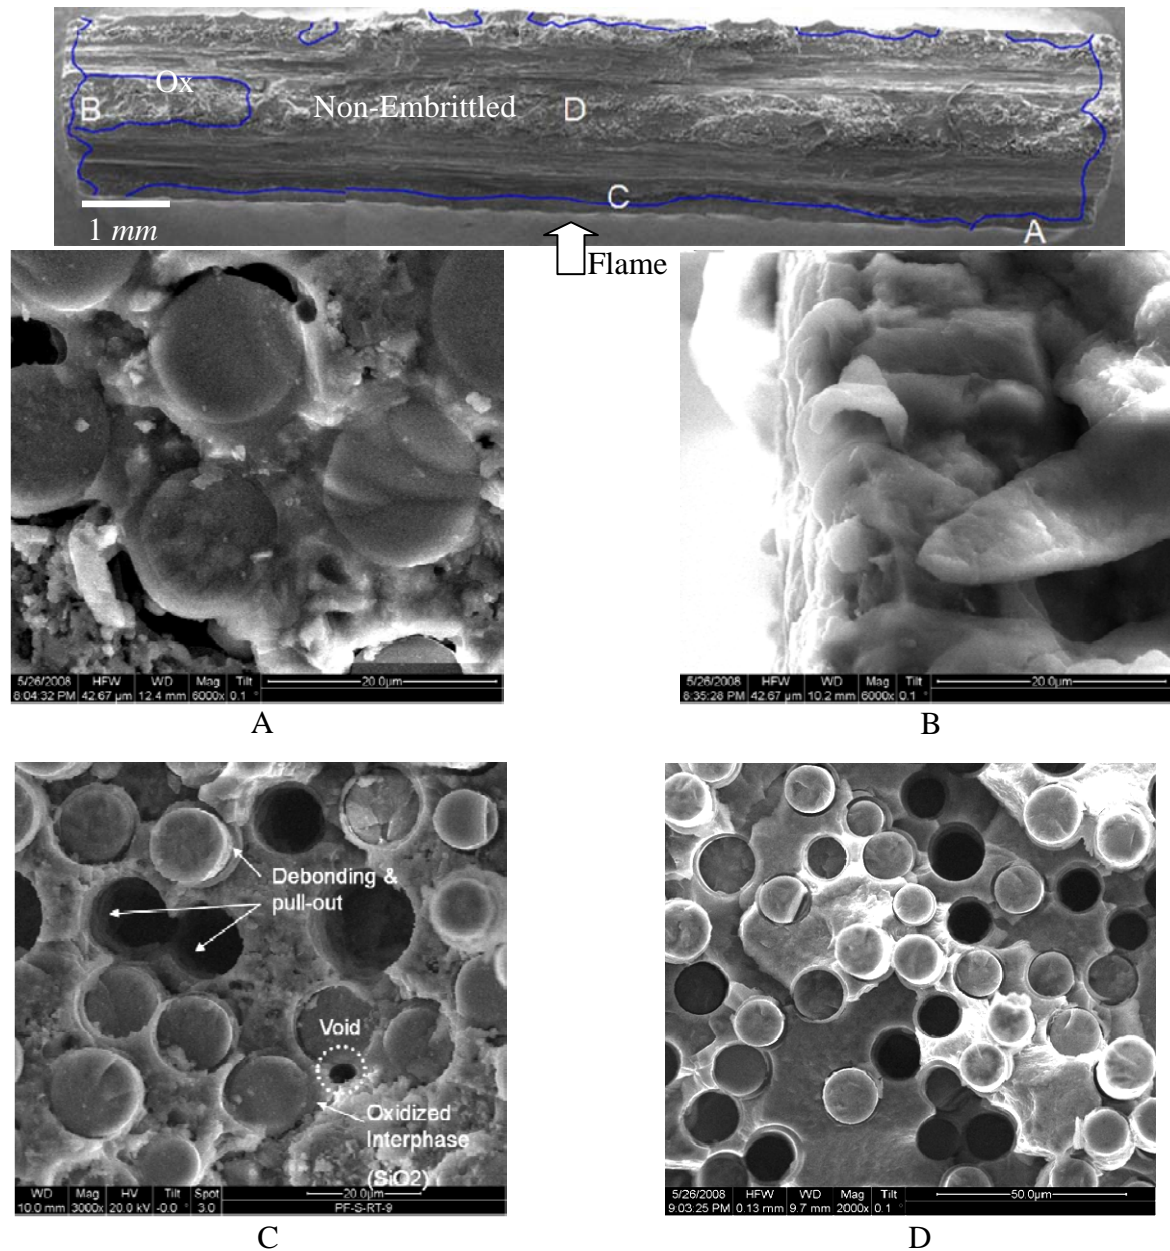
Figure 75: Fracture surface of the prepreg MI Hi-Nic-S/BN/SiC that survived peak stress of 92 MPa after residual strength test: A thru D are from the residual fracture surface as shown and denoted on the above figure.

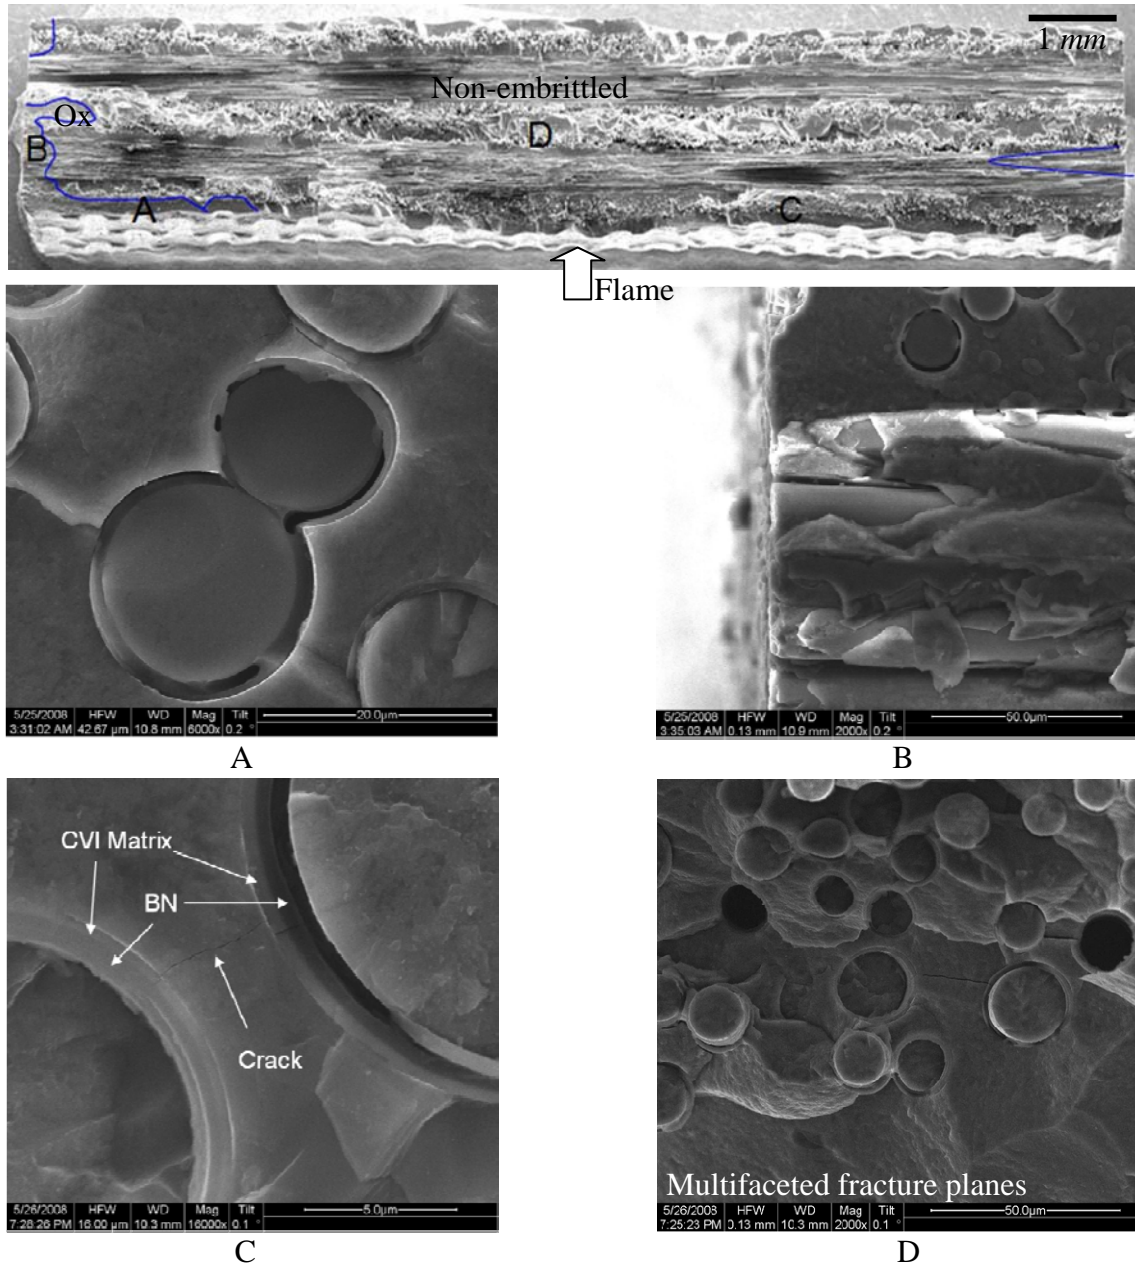
Figure 76: Fracture surface of the prepreg MI Hi-Nic-S/BN/SiC that survived peak stress of 105 MPa after residual strength test: A thru D are from the residual fracture surface as shown and denoted on the above figure.

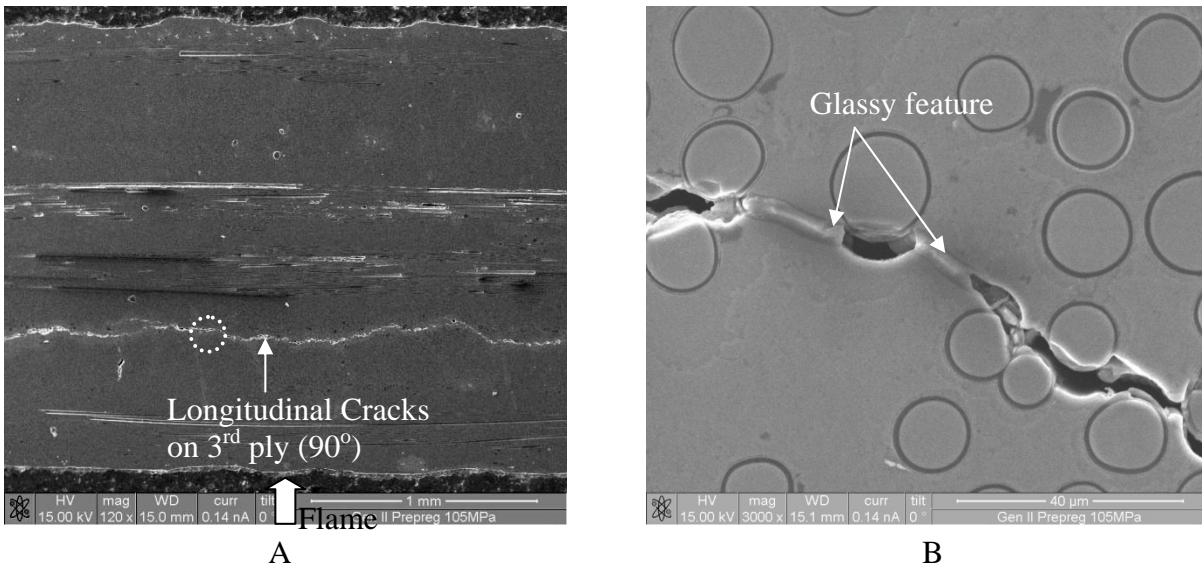
Figure 80: (A) A longitudinal crack found on the 3rd ply from the impacted surface; (B) encircled area in (A) showing glassy feature

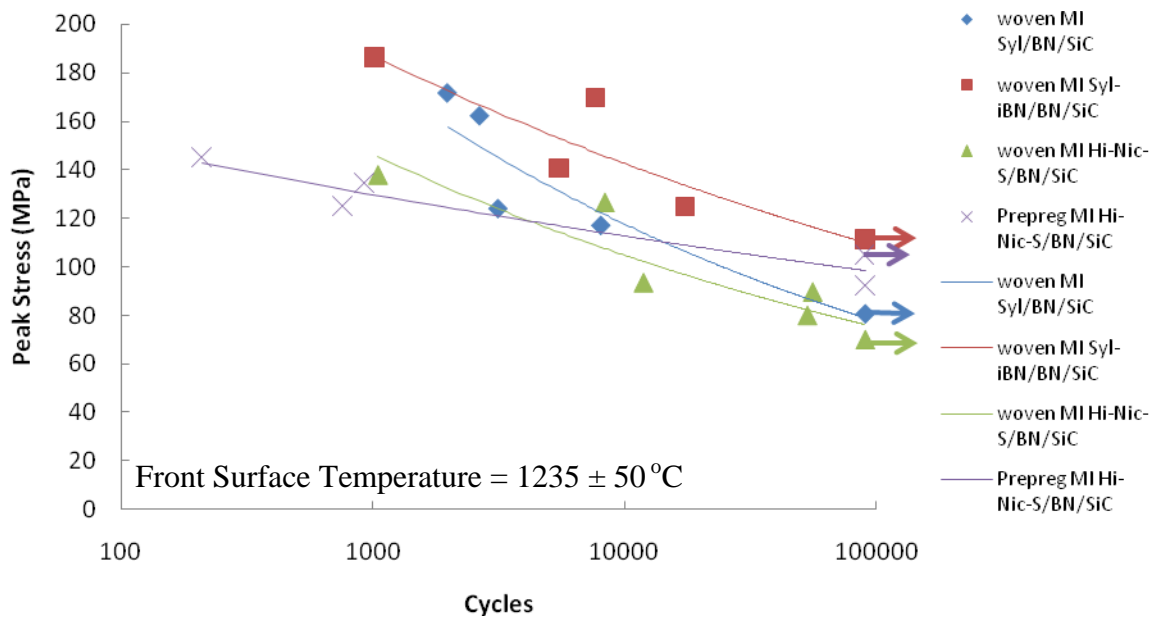
Figure 82: S-N Data for all four CMCs

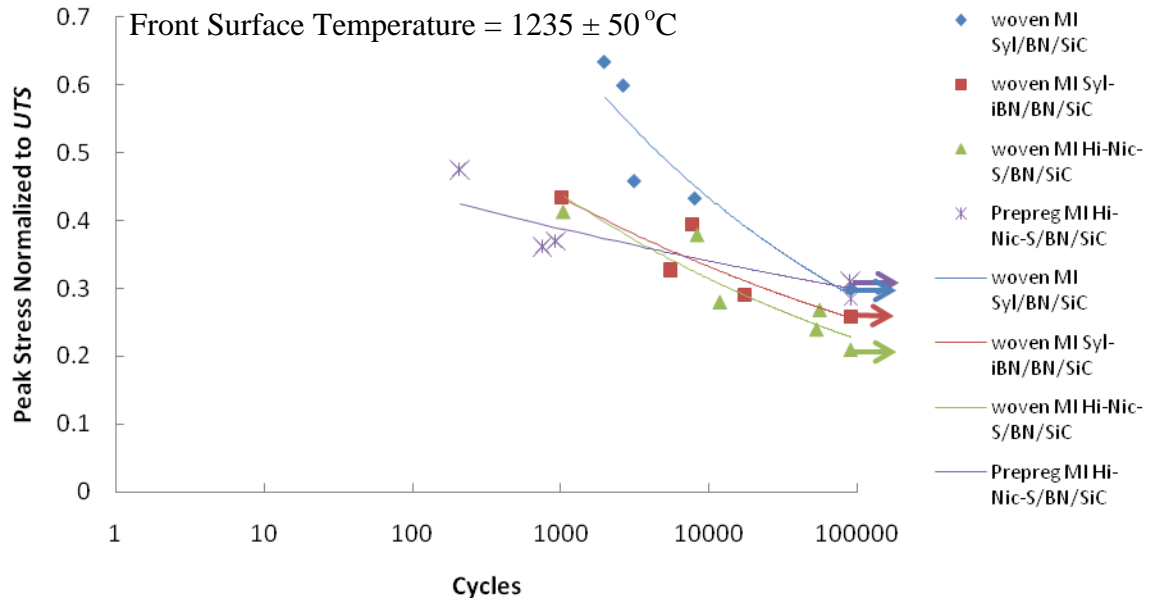
Figure 83: S-N Data with peak stresses normalized against UTS

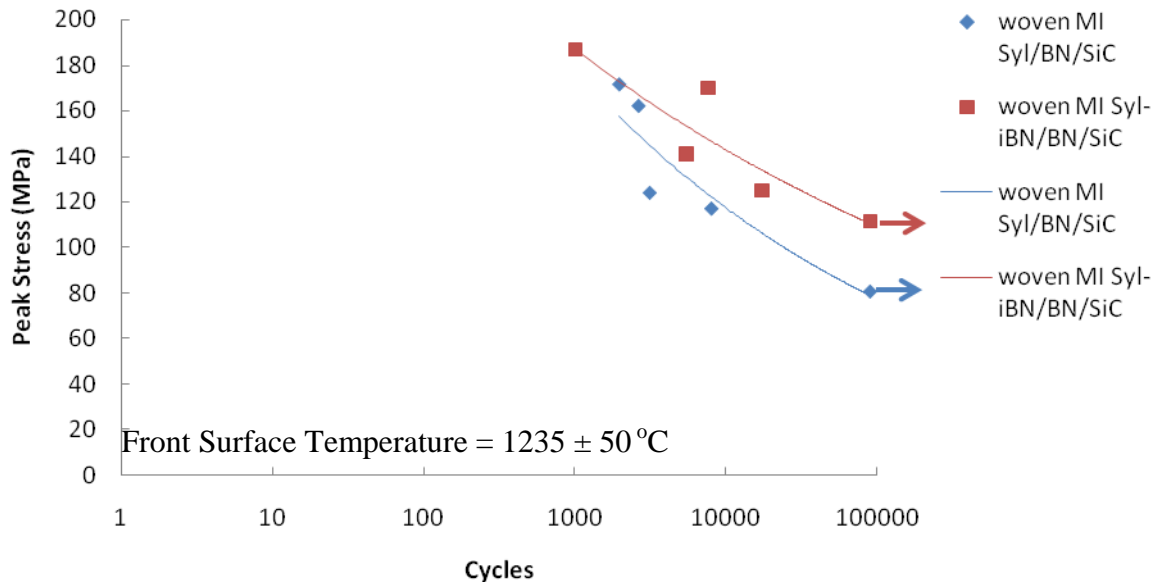
Figure 86: S-N data of the woven MI Syl-*i*BN/BN/SiC and the woven MI Syl/BN/SiC

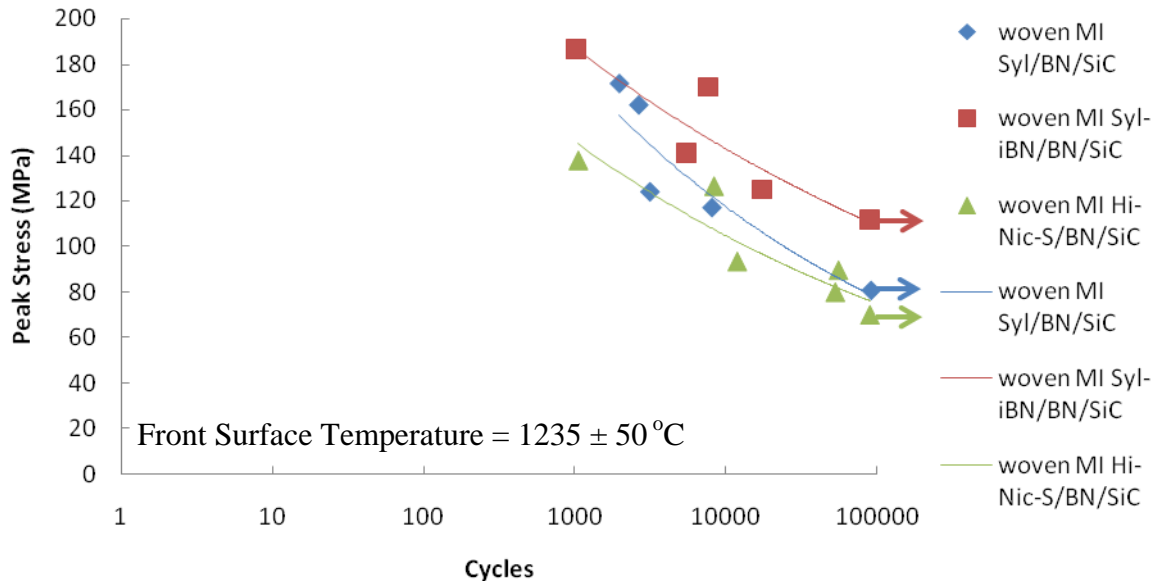
Figure 91: S-N data for the three woven MI CMCs

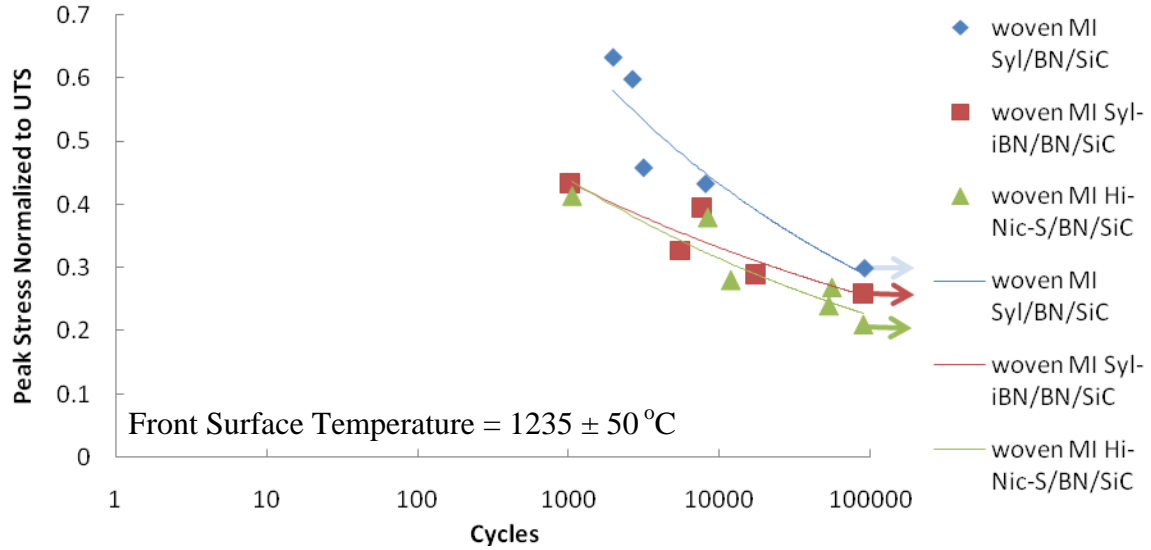
Figure 92: S-N Data with peak stress normalized against *UTS*

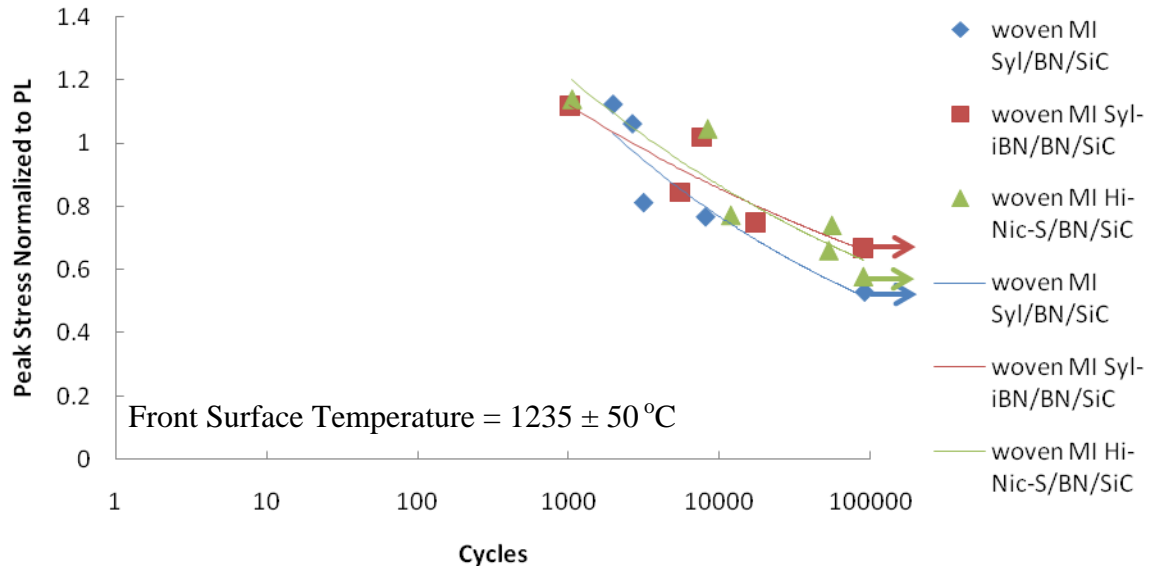
Figure 93: S-N Data with peak stress normalized against *PL*

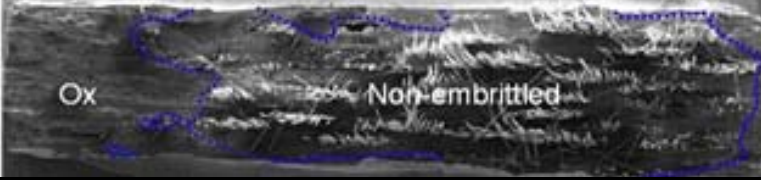
On the comparison of the MI Syl/BN/SiC and MI Hi-Nic-S/BN/SiC, the area fraction of the oxidized region for the Hi-Nic-S MI CMC is considerably greater than the Syl MI CMC. The applied peak stress of 125 ± 2 MPa was 105 % of the *PL* for the Hi-Nic-S MI CMC, as compared with 81% of the *PL* for the Syl MI CMC. Thus, the Hi-Nic-S MI CMC in a greater relative stress with respect to the *PL* would presumably be at a more highly developed state of matrix cracking. The higher porosity in the Hi-Nic-S MI CMC may have also given way to oxidation such that a larger oxidized area was attained on the MI Hi-Nic-S/BN/SiC. However, the MI Hi-Nic-S/BN/SiC showed a greater fatigue life than the Syl MI CMC at the common peak stress of 125 ± 2 MPa. This observation is opposite of the one from the earlier comparison, which showed the woven MI Syl-*iBN*/BN/SiC has the higher fatigue life than the woven MI Hi-Nic-S/BN/SiC. This could be, in part, attributed to the absence of the in-situ BN coating. It may also be attributed to the scatter in the experimental data, as the fatigue life of the two were separated by relatively low

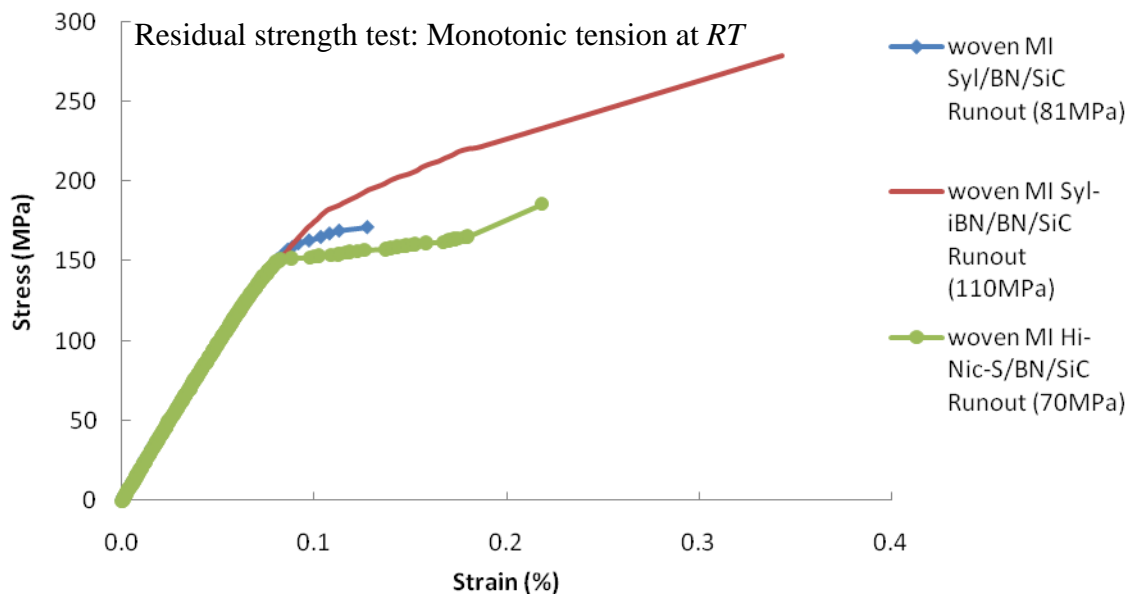
Figure 94: Stress-strain response of the three woven MI CMCs under monotonic tension after surviving 90000 cycles of fatigue loading in combustion

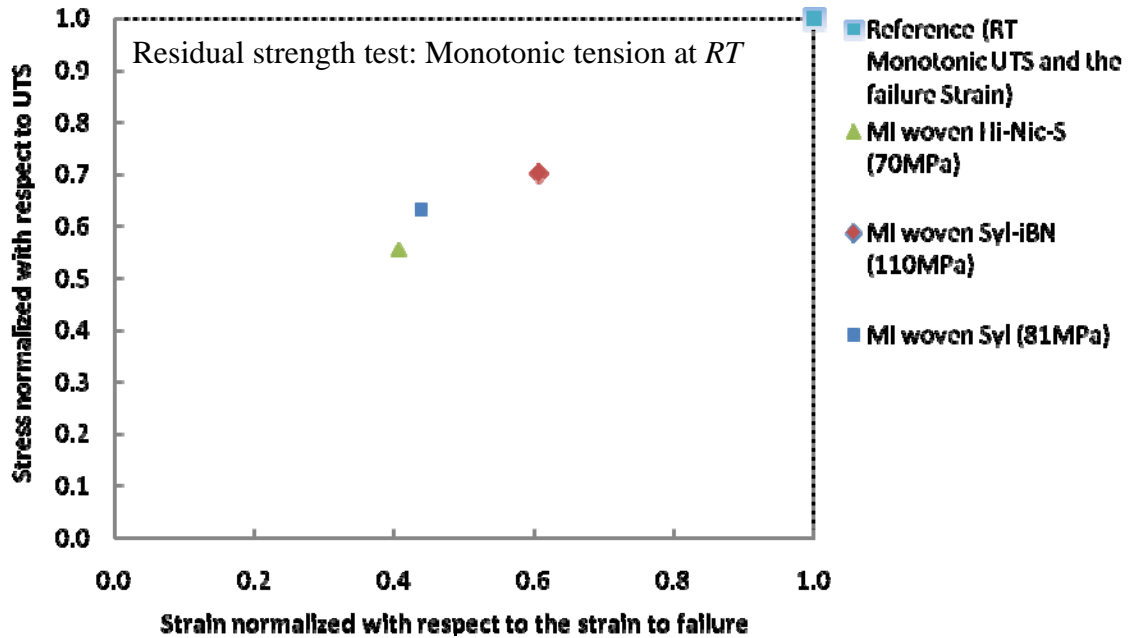
Figure 95: The stress-strain curves shown in Figure 94 with the stress and strain axes normalized against the *UTS* and the corresponding strain at *UTS*, respectively

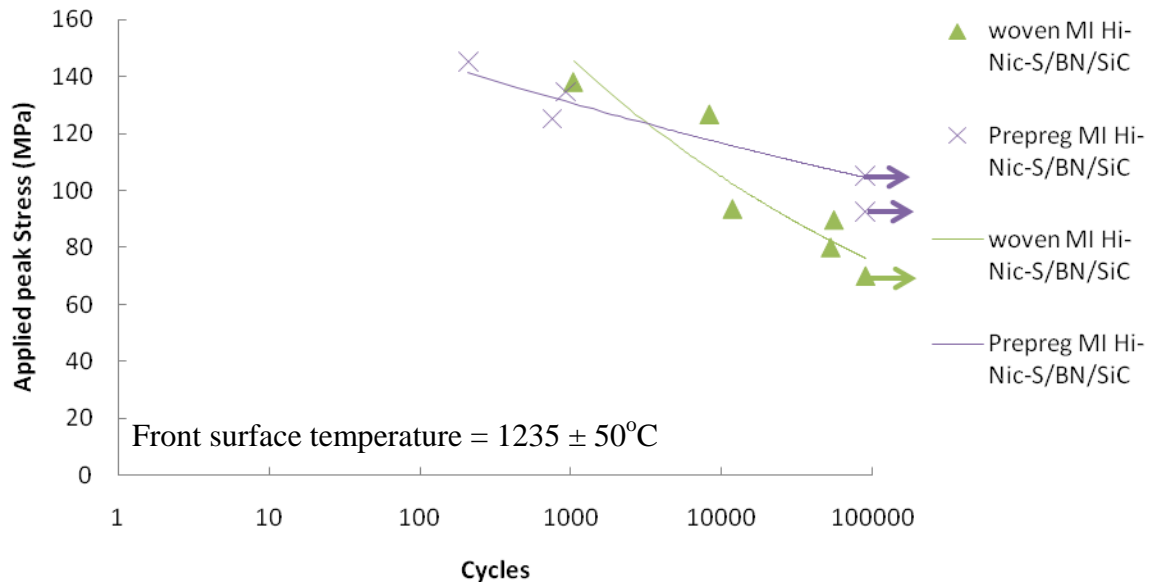
Figure 96: S-N data of the prepreg MI and the woven MI Hi-Nic-S/BN/SiC

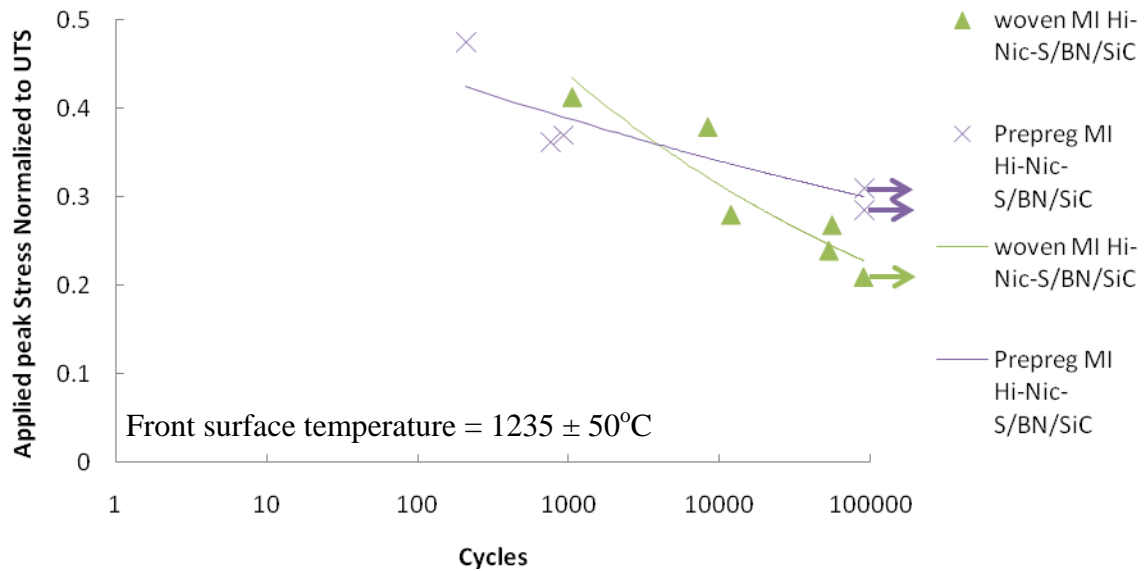
Figure 97: S-N data of the two MI Hi-Nic-S/BN/SiC CMCs with peak stress normalized against *UTS*

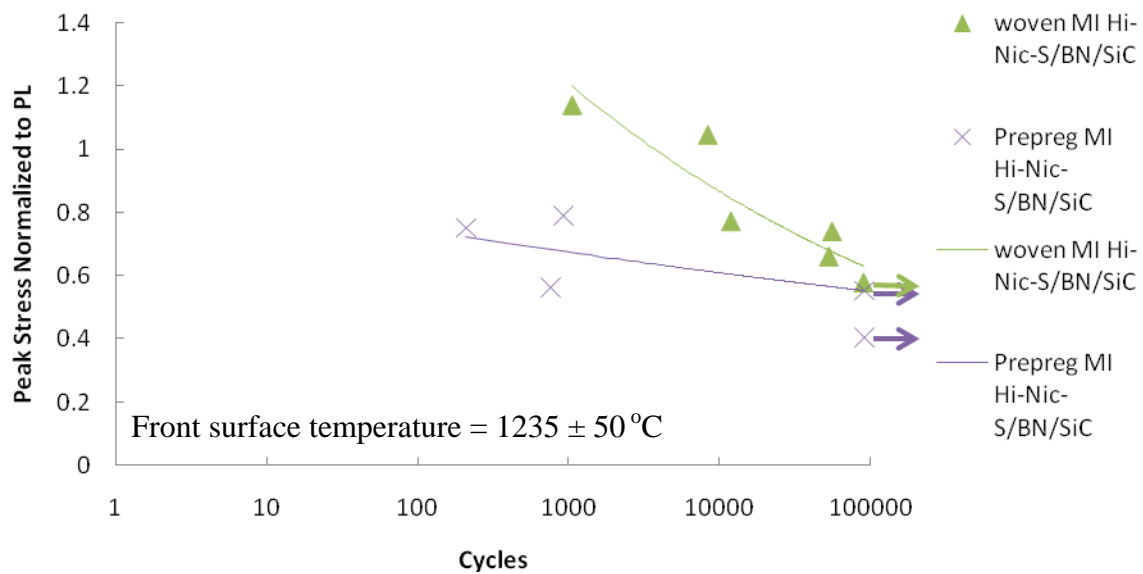
Figure 98: S-N data of the two MI Hi-Nic-S/BN/SiC CMCs with peak stress normalized against *PL*

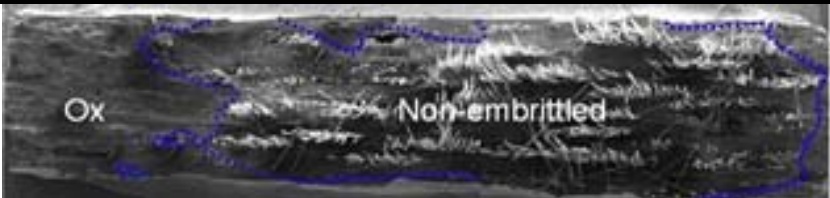
Table 26: Fracture surfaces for the woven MI and prepreg MI Hi-Nic-S/BN/SiC both fatigue loaded at the same peak stress of 125 MPa

Peak Stress (MPa)	CMC Type	Fracture Surface	Cycles-to-failure
125 ± 2	Woven MI Hi-Nic-S/BN/SiC

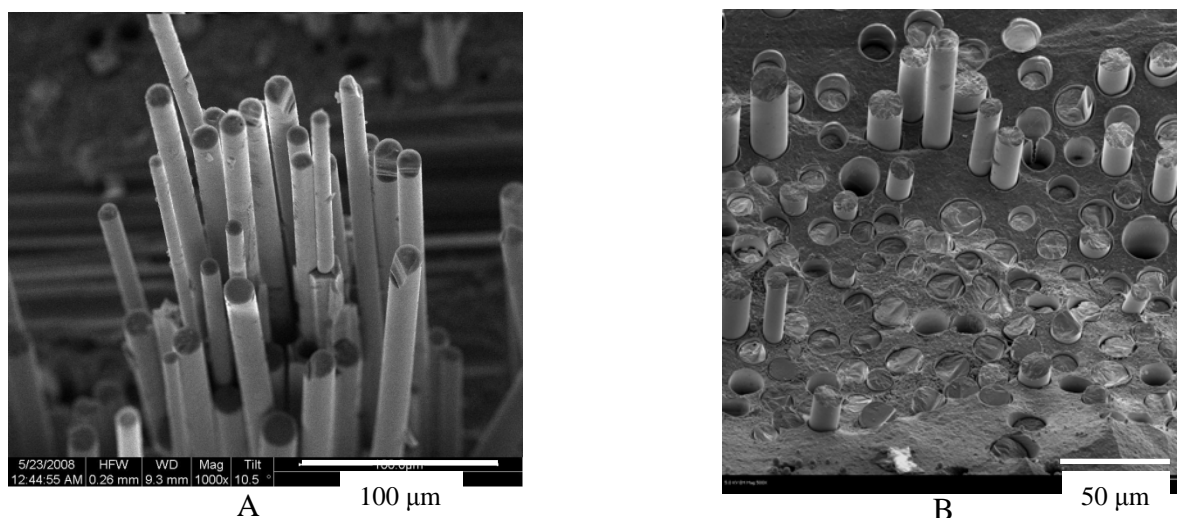
Figure 99: Fiber pullout in the non-embrittled regions of the two CMCs; (A) Long fiber pullout typical of the woven MI Hi-Nic-S/BN/SiC fractured after 53034 cycles under the peak stress of 80 MPa, (B) short pullout typical of the prepreg MI Hi-Nic-S/BN/SiC failed after 758 cycles under 125 MPa

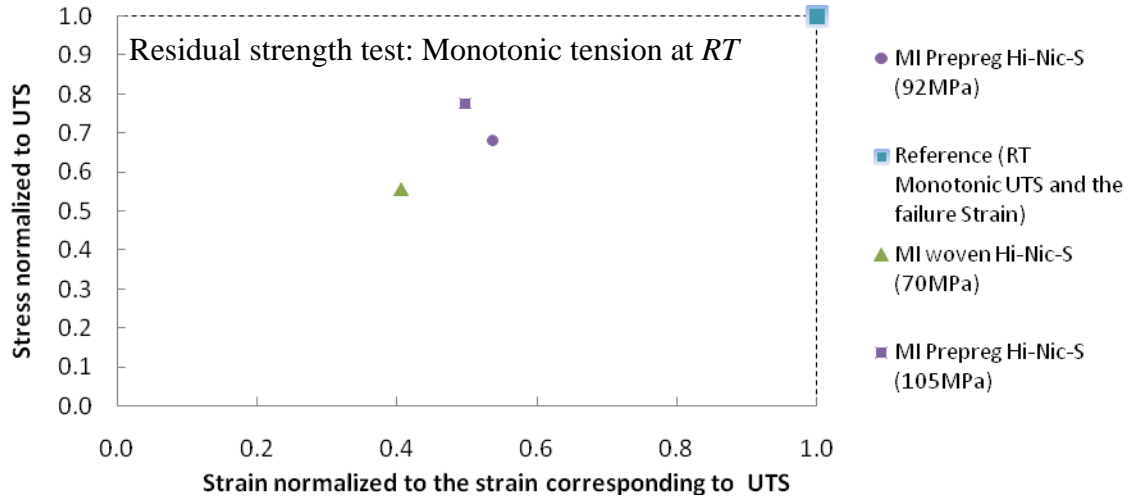
Figure 102: The stress-strain curves shown in Figure 101 with the stress and strain axes normalized against the *UTS* and the corresponding strain at *UTS*, respectively

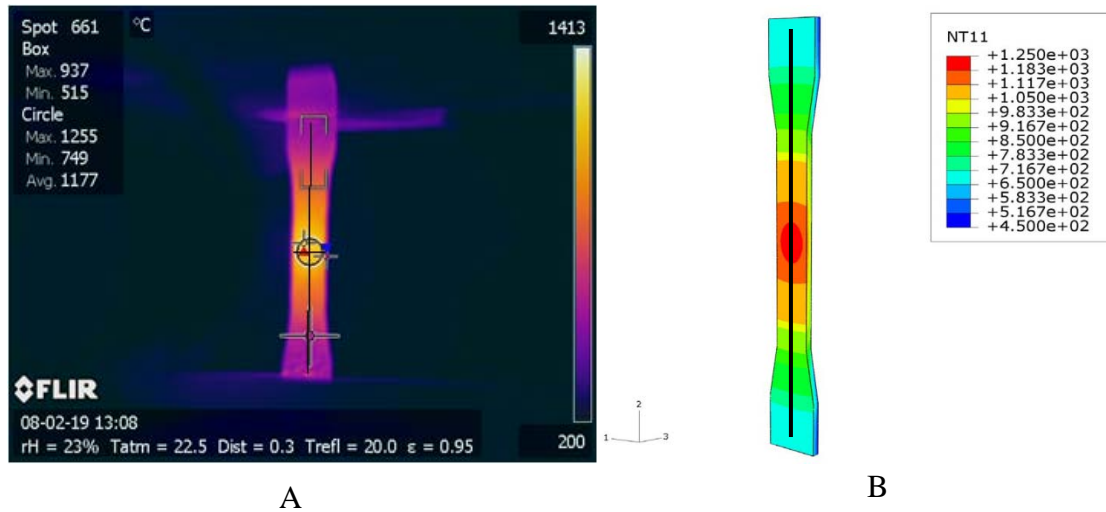
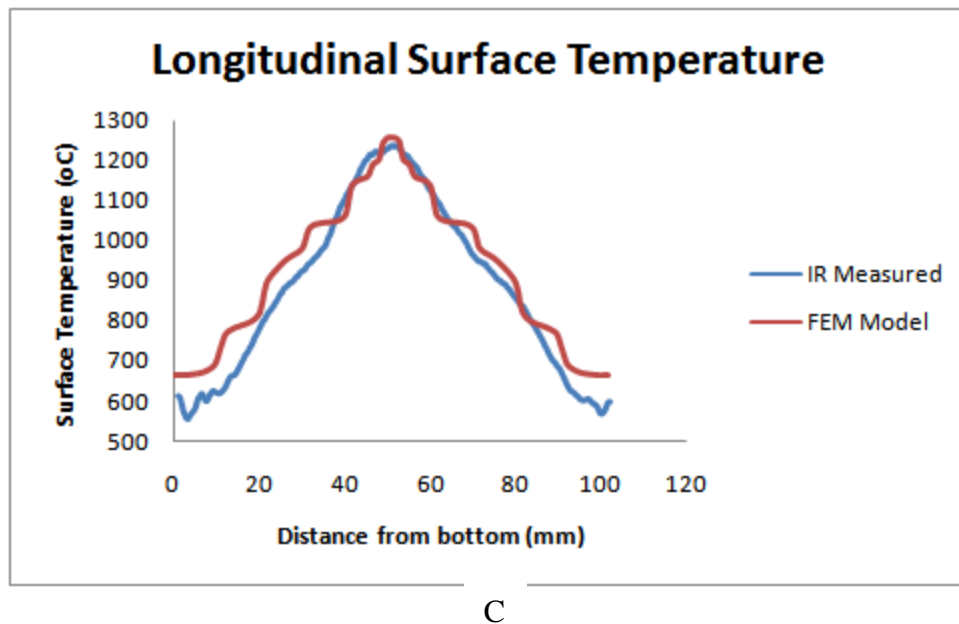
Figure 103: Surface temperature profile on the front surface; (A) measured along the longitudinal axis as shown using IR, (B) modeled in ABAQUS; (C) comparison between measured and modeled along the longitudinally drawn line in (A) and (B).

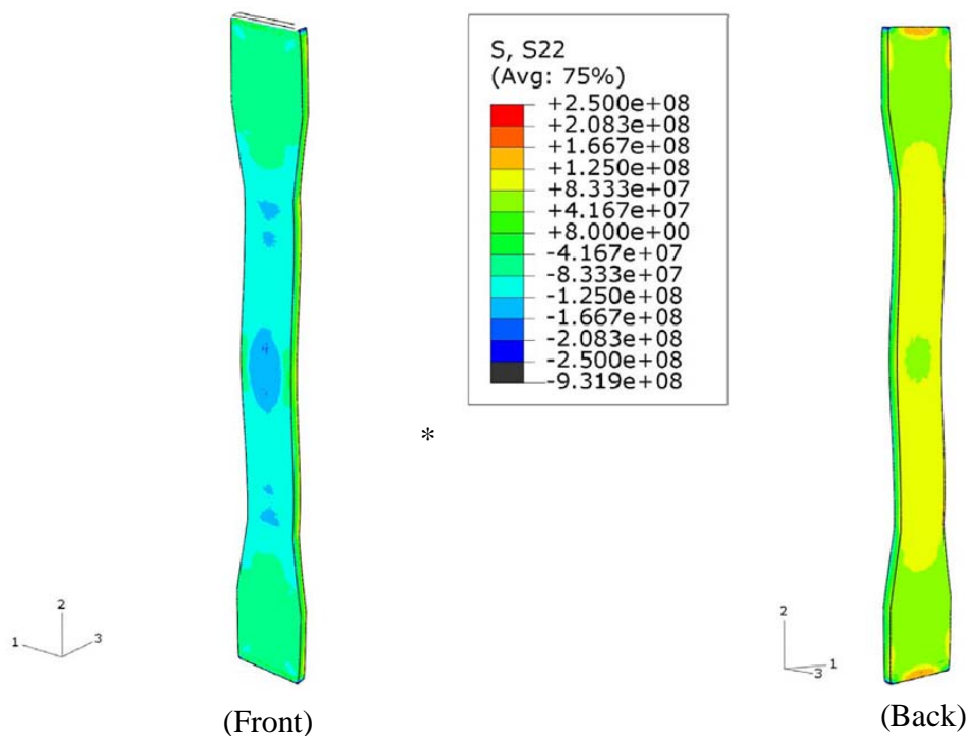
Figure 106: Stress induced by thermal gradient represented in color contour: Stress in the longitudinal direction (S22) Deformation is magnified for illustration by 33.5 times
